Tree Risk Assessment Report

836 John Street

River Forest, Illinois

October 16, 2017

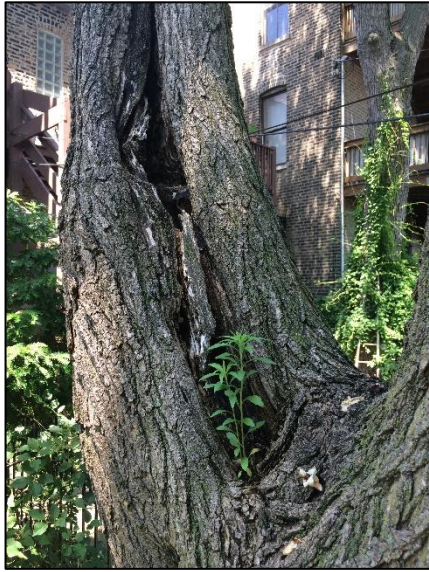
There is a cavity in the western stem from the main split to a height of 12 feet. The cavity is 6 to 8 inches across along its entirety. There is visual evidence of decay in the cavity, with decay likely present further up the stem than is visually evident. The main, combined stem has a large, old seam from the ground to a height of 5 feet. This could be an indication of an old wound and possible internal decay.

Fig. 1. Cavity and decay in western stem

The western stem had an estimated average sound wood depth of 2.5 inches radially, meaning that there is approximately 5 inches of sound wood through the diameter of the largest branch. It is generally accepted that tree decay is considered severe when 15 percent or less of the tree's diameter is made up of sound wood. Given the tree diameter of 20 inches, 4.5 inches of sound wood is well above this mark at 25 percent. The cavity reduces the stem's strength somewhat, but not to a critical level.

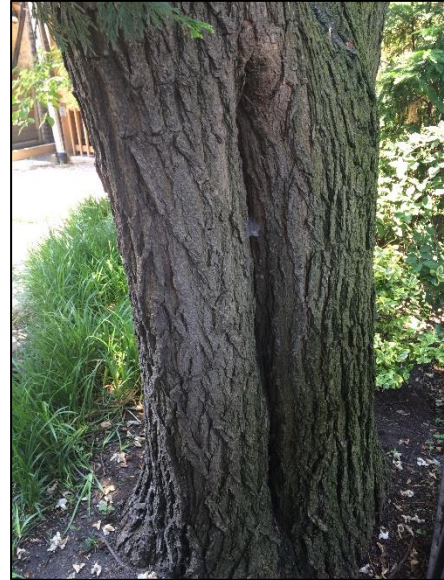
Fig 2. Seam along northeast side of tree.

The combined stem had an estimated sound wood depth of 5 inches radially, meaning that there is approximately 10 inches of sound wood through the diameter of the largest branch. Given the tree diameter of 30 inches, 4.5 inches of sound wood is well above the recommended 15 percent mark, at 33 percent.
